Rimkus Consulting Group, Inc.
Eight Greenway Plaza, Suite 500
Houston, TX 77046
(800) 580-3228 Telephone
(713) 623-4357 Facsimile

Re: RCG File No: 11009971
LLV Number: 0209452
VMF Location: 1530 Greensmark Drive in Houston, Texas
Subject: Final Report

Rimkus Consulting Group, Inc. was retained to examine LLV 0209452, VIN 1GBCS10E4M2908832. The fire occurred on June 13, 2016 at around 12:30 P.M. the operator of the vehicle at the time of the fire, was unavailable for interview but reportedly stated the vehicle's engine died while delivering mail on his route and backfired during subsequent attempts to restart it. Soon thereafter, smoke was observed from beneath the hood as well as flames.

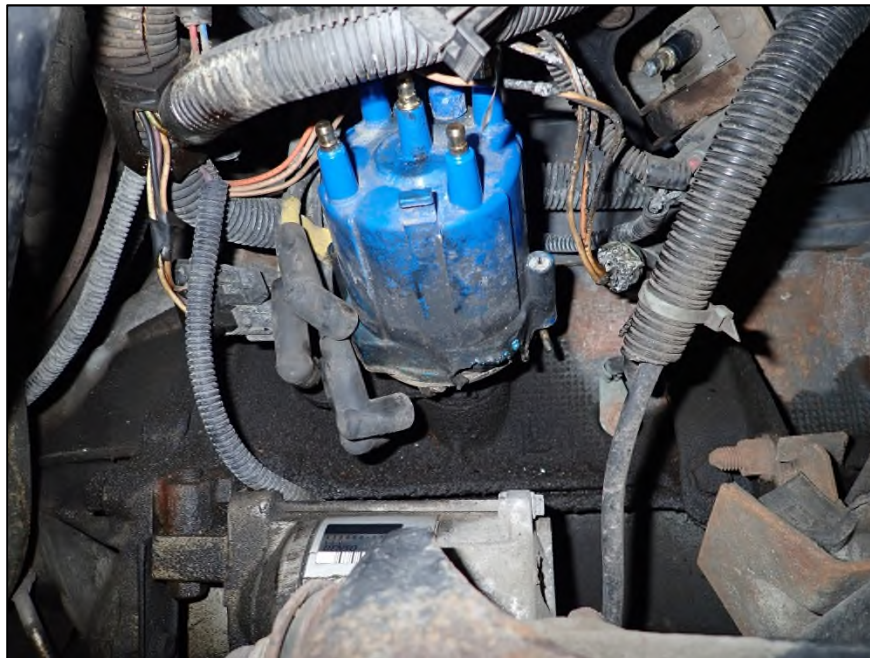
Photograph 14

Distributor cap on the driver's side of the engine.

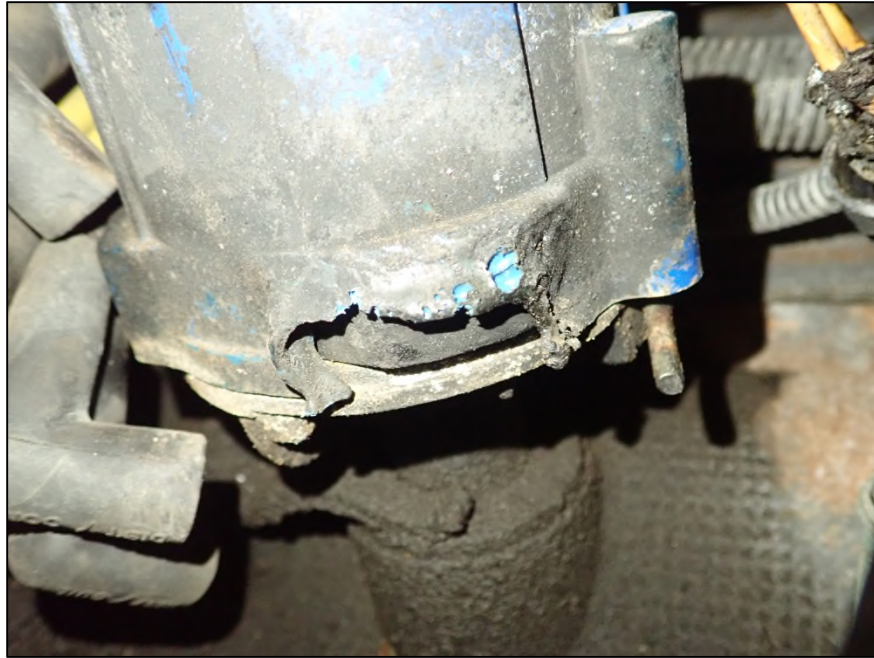
Photograph 15

Close-up view of the damage to the distributor cap.

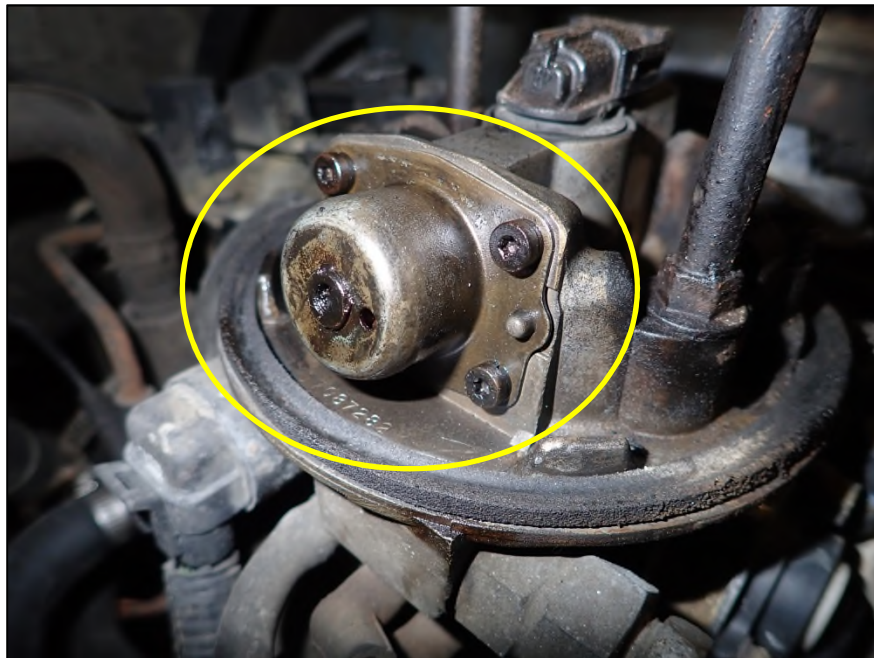
Photograph 18

Fuel pressure regulator covered with gasoline once the system was pressurized.

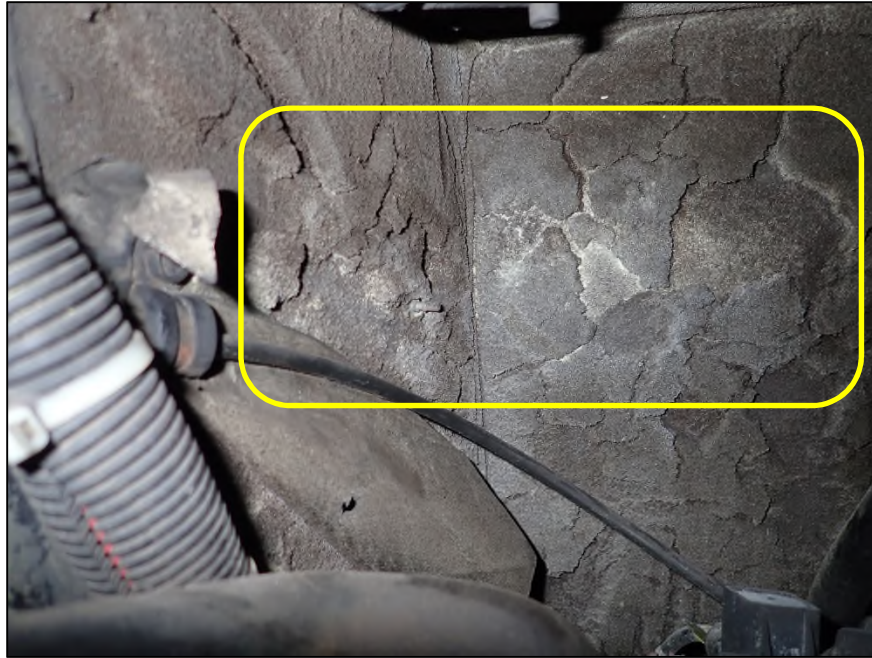
Photograph 19

Dry chemical extinguisher remains on the insulation attached to the bulkhead.

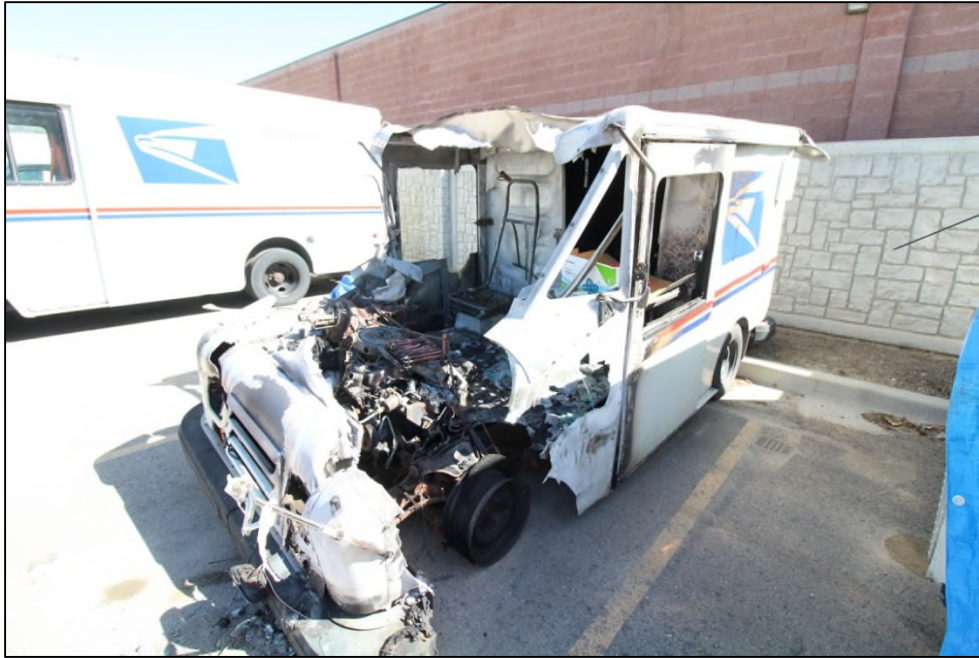
Photograph 1
Front and mail side of LLV.

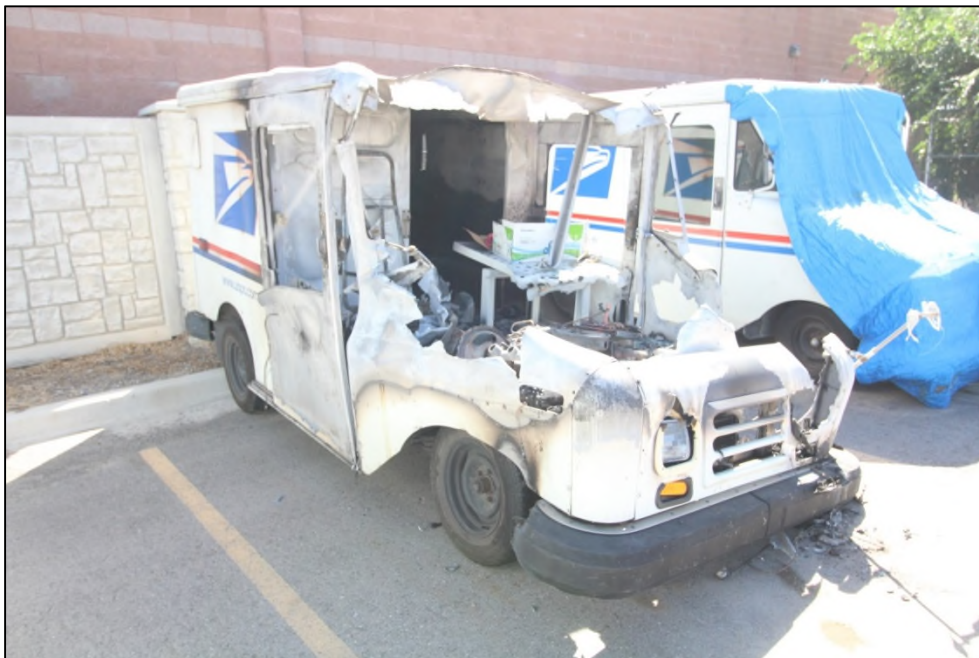
Photograph 2
Driver's side.

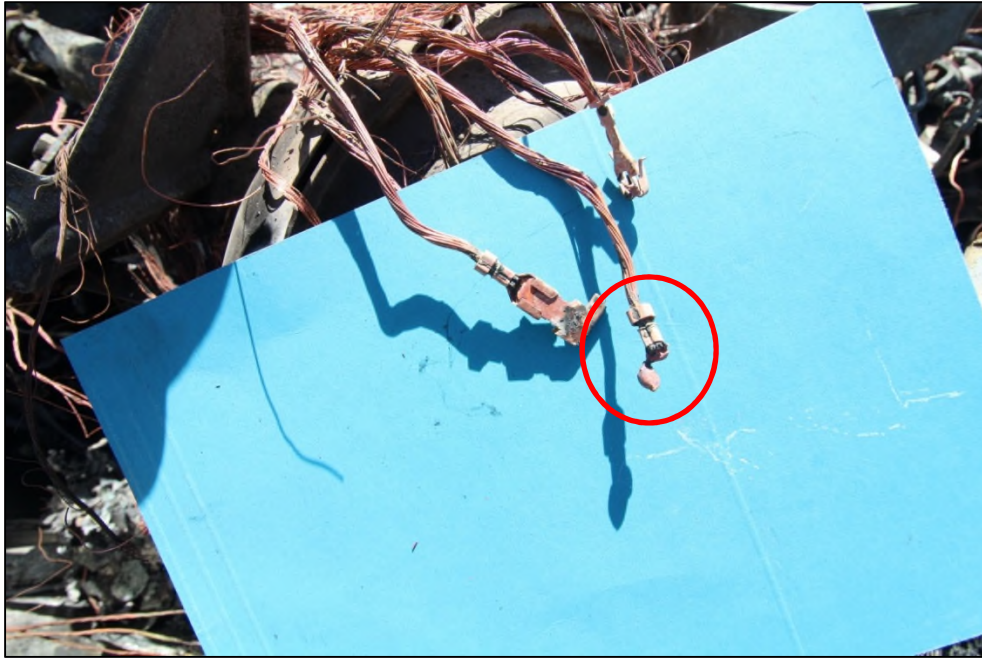
Photograph 3

The fuse panel had been consumed by the fire. The connector end of one of the electrical conductors that had been connected to the fuse panel was melted. All other connector ends were not damaged to this extent from the fire. The insulation to all of the electrical conductors that had been connected to the fuse panel had been consumed by the fire.

Melted connector end of electrical conductor from fuse panel.

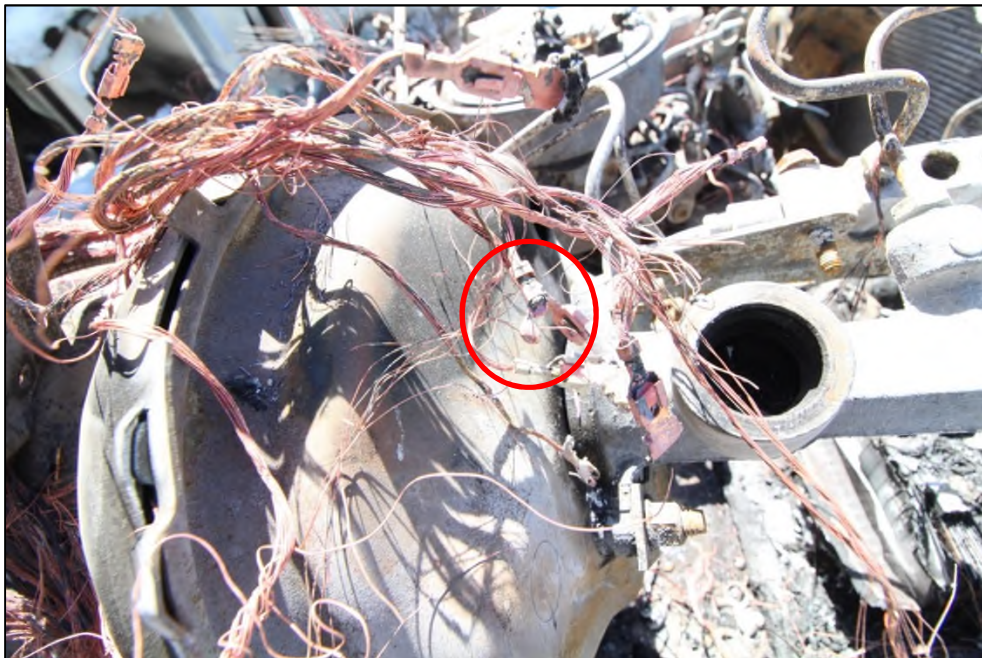
Photograph 4

Multiple electrical conductors from fuse panel. One with melted connector circled.

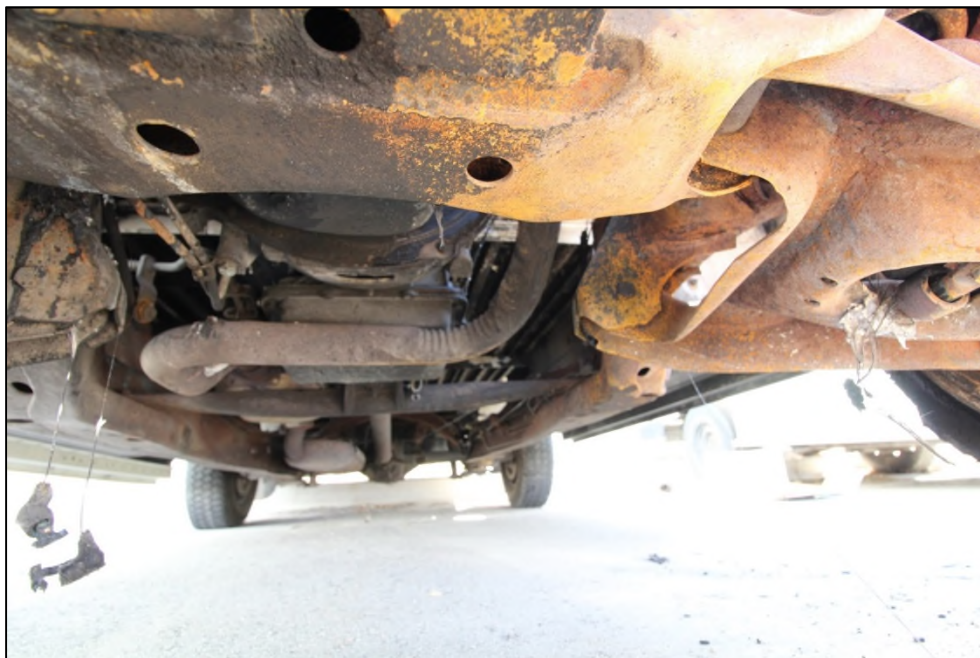
Photograph 6

There was no damage from the fire to the undercarriage. There was no indication of any major fluid leaks from the engine, transmission or the differential in the undercarriage. The LLV was mounted on a GM general frame and was undamaged.

Undercarriage.

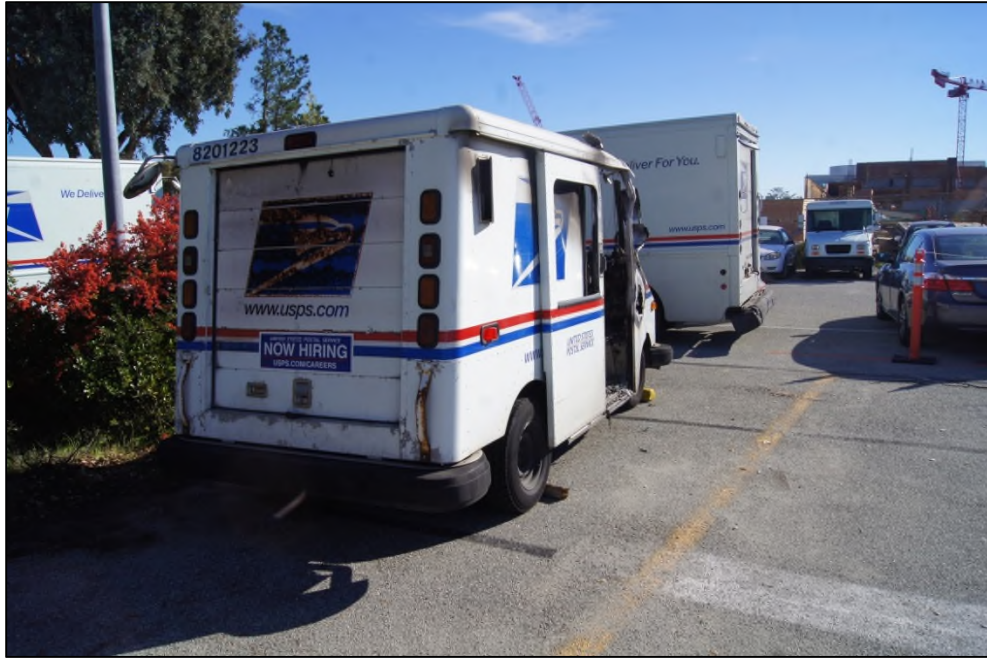
Photograph 1
Rear of LLV.

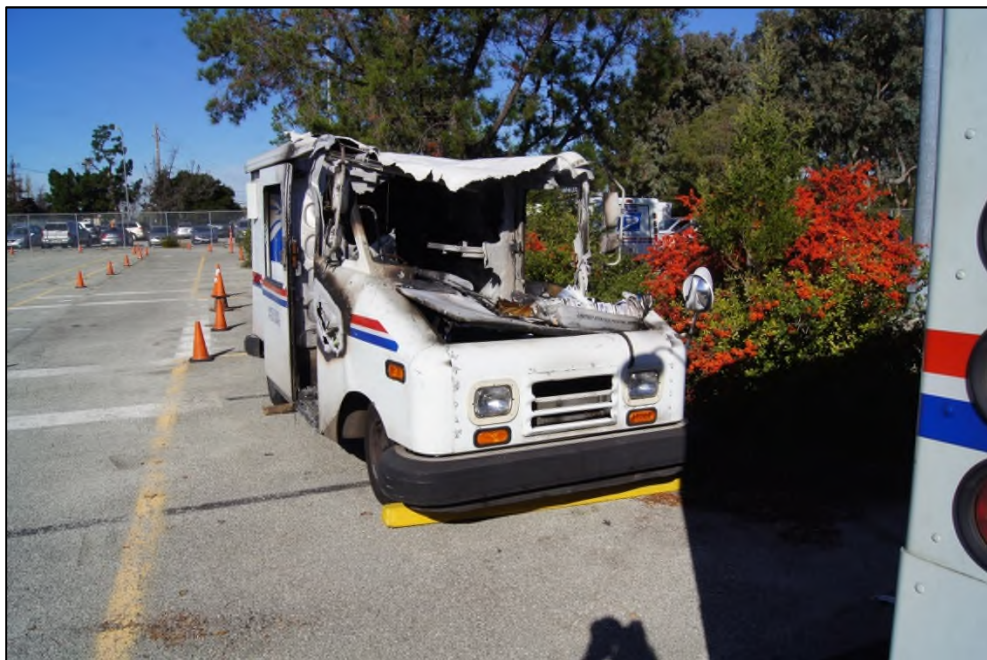
Photograph 2
Front of LLV.

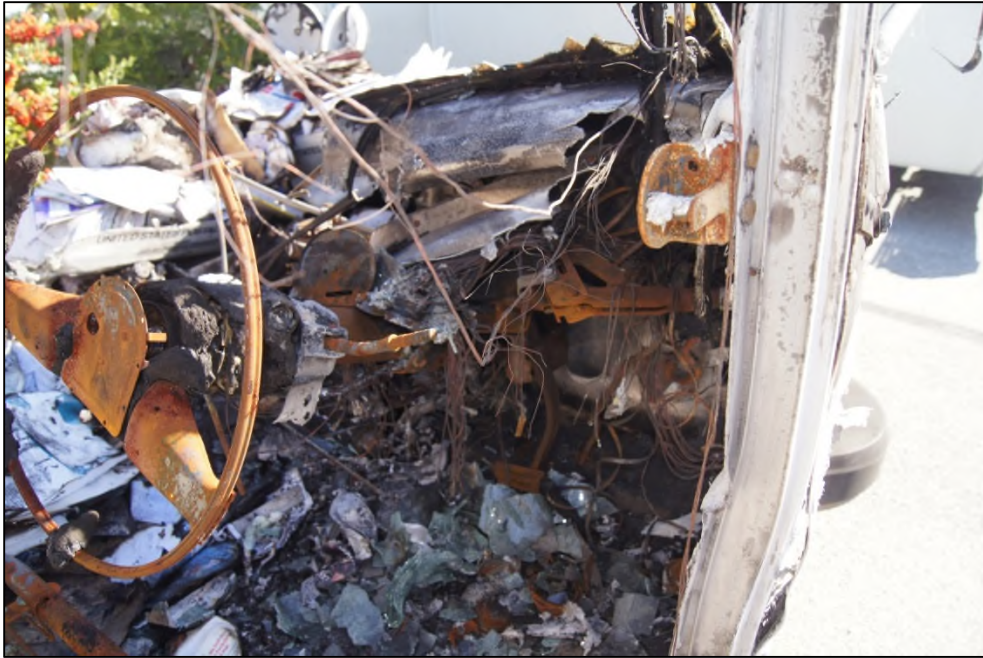
Photograph 3
Dash area.

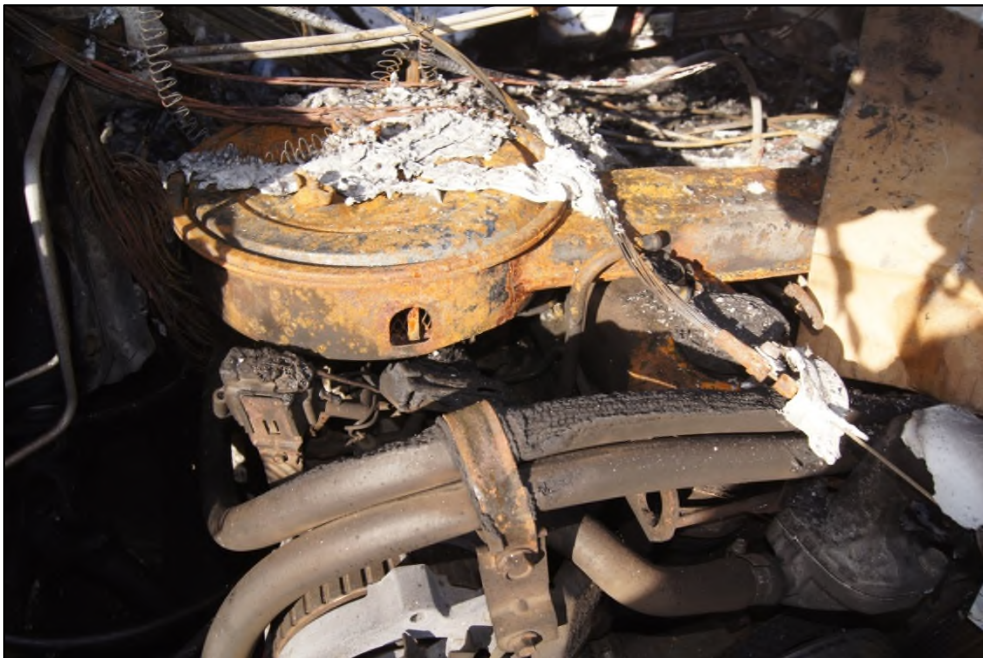
Photograph 4
Engine compartment .

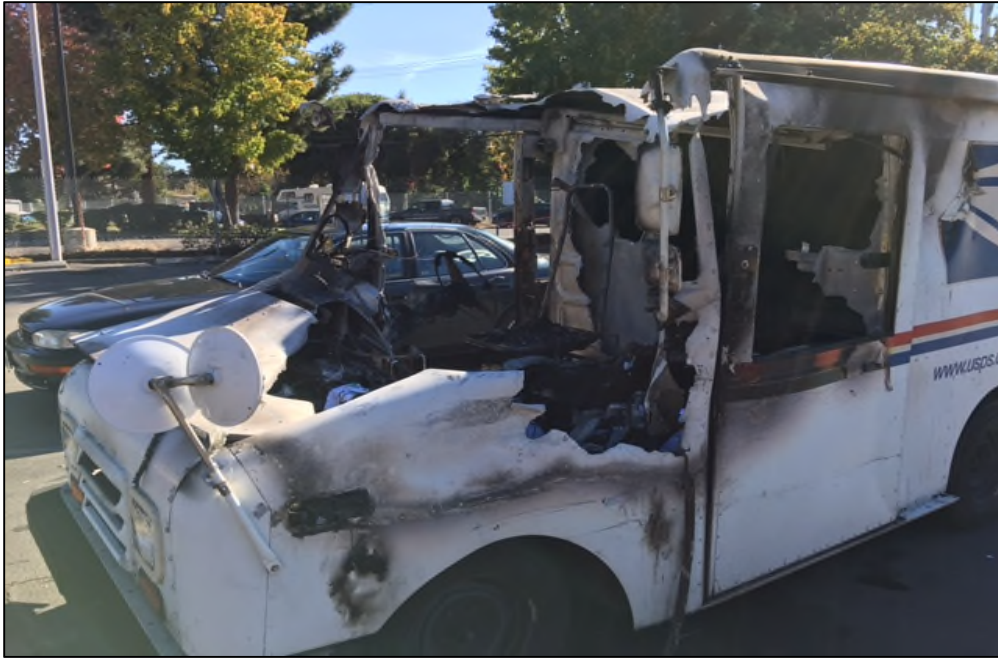
Photograph 5

Fire damage to dashboard area.

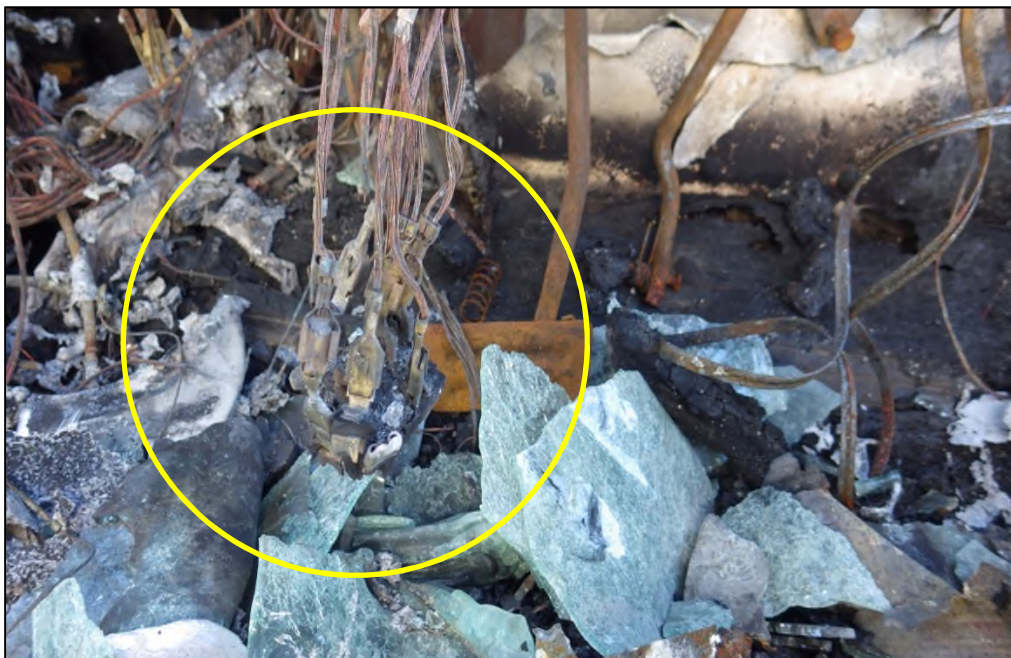
Photograph 6

Remains of the headlight switch harness.

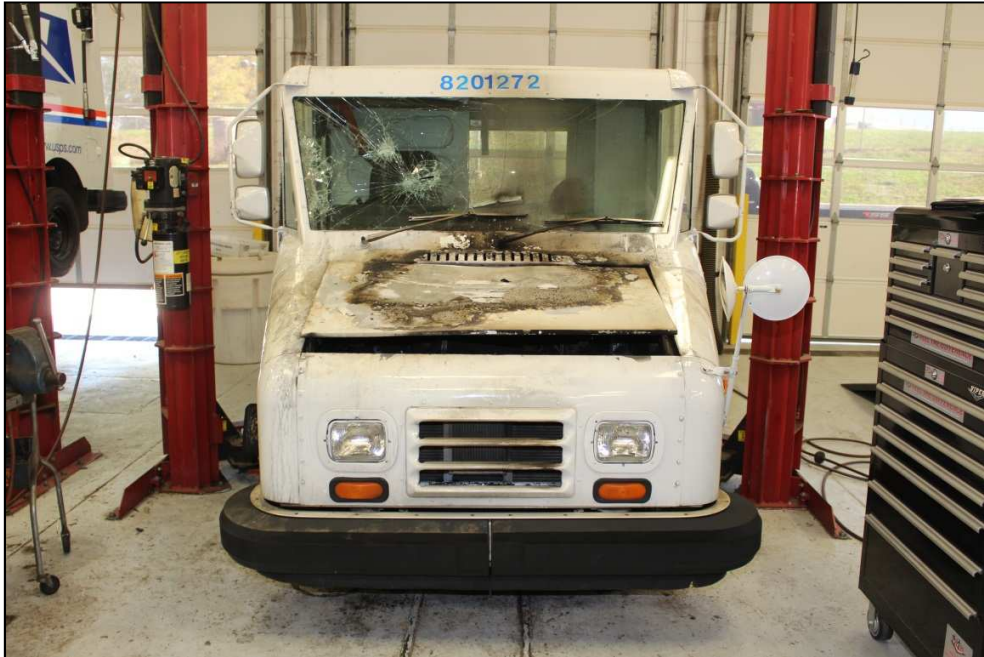
Photograph 1
Front view.

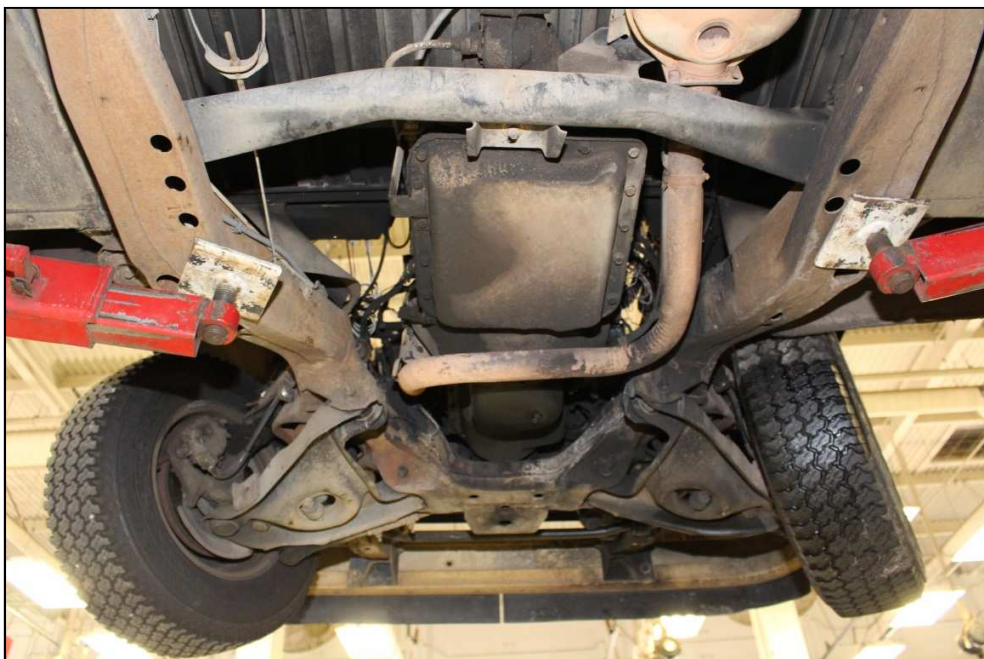
Photograph 2
Undercarriage view of front portion.

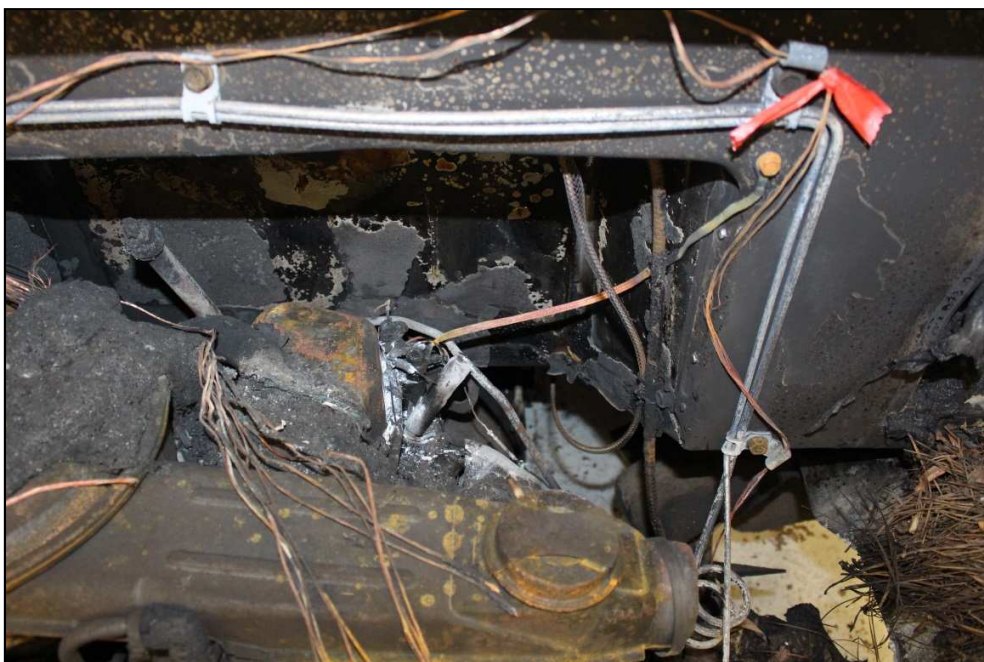
Photograph 4

An additional view of the area of fire origin. The red flag tape outlines an area of electrical activity that was utilized during arc fault mapping.

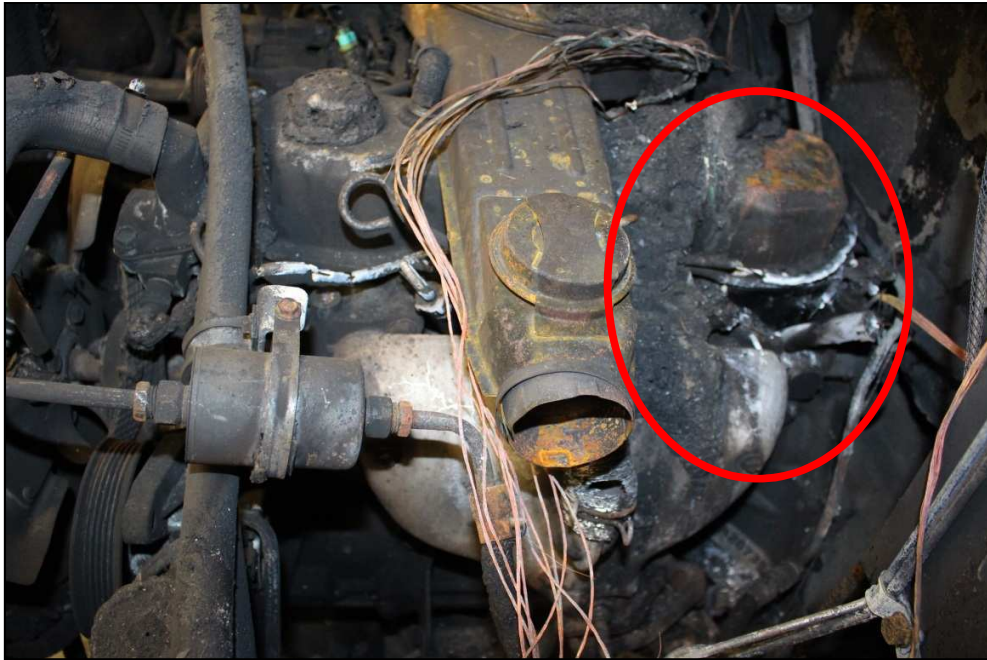
Photograph 5

View of the area of fire origin.

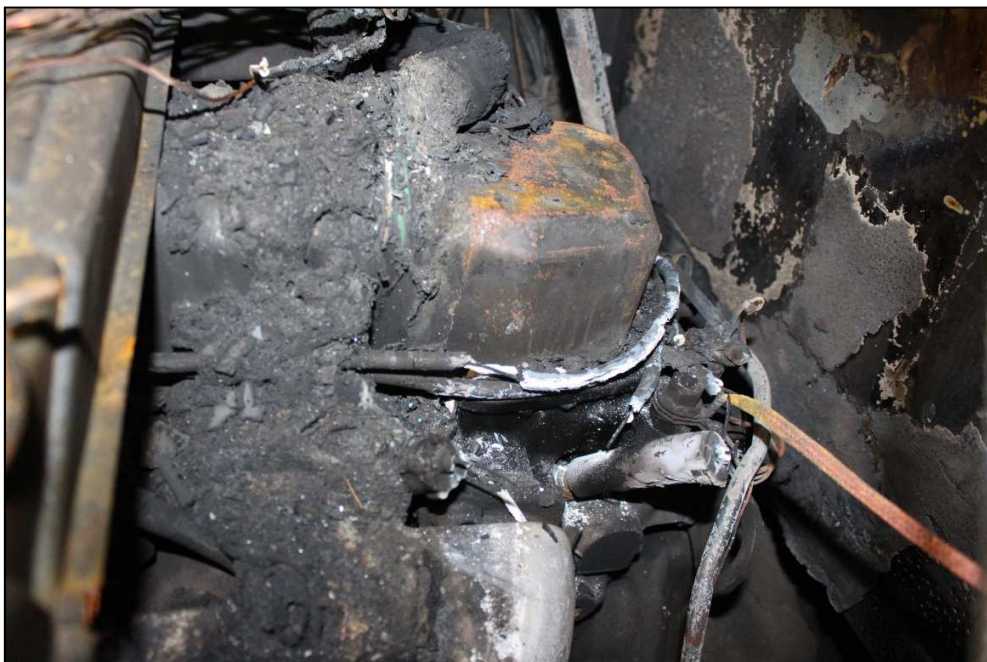
Photograph 6

A closer view of the area of fire origin.

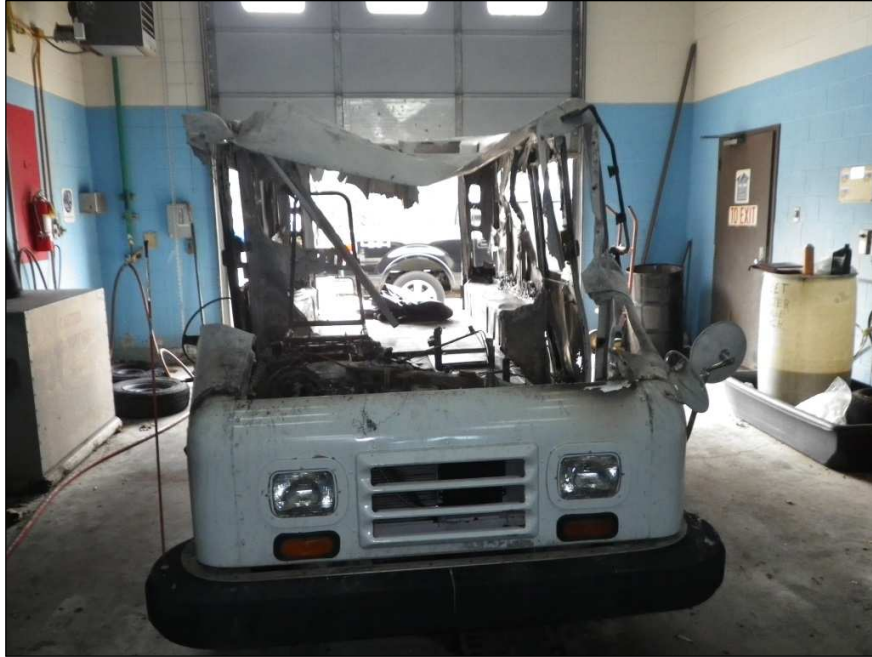
Photograph 1
View of front of vehicle.

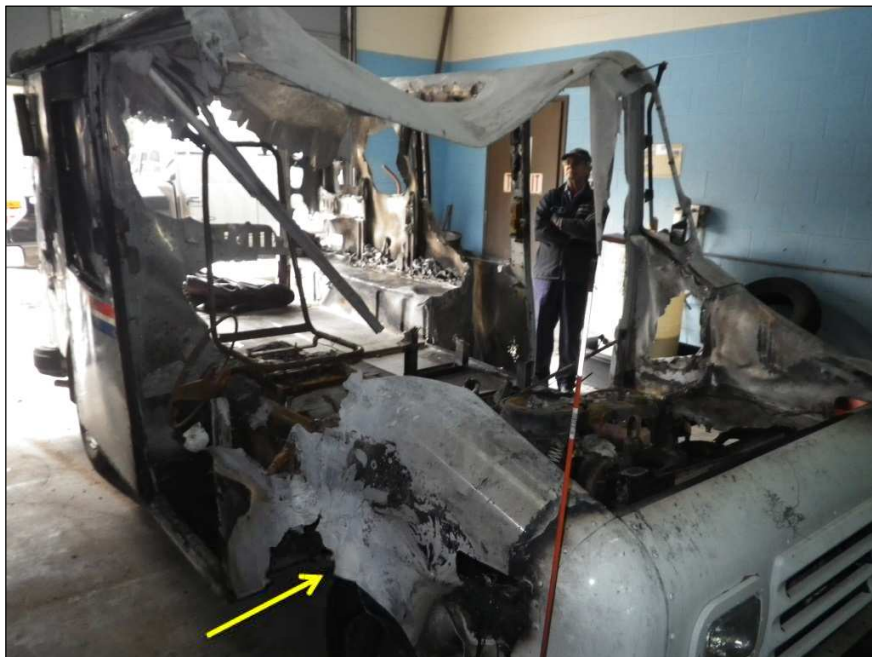
Photograph 2
View of fire damage and pattern on driver side fender. Arrow indicates area of origin.

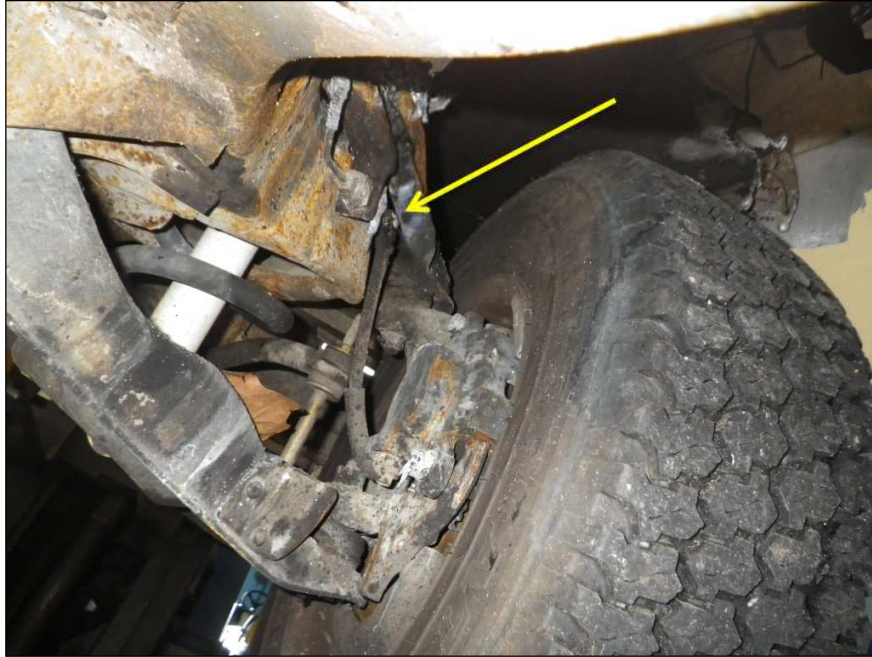
Photograph 3

View of area of origin on driver side. Arrow indicates damaged brake line.

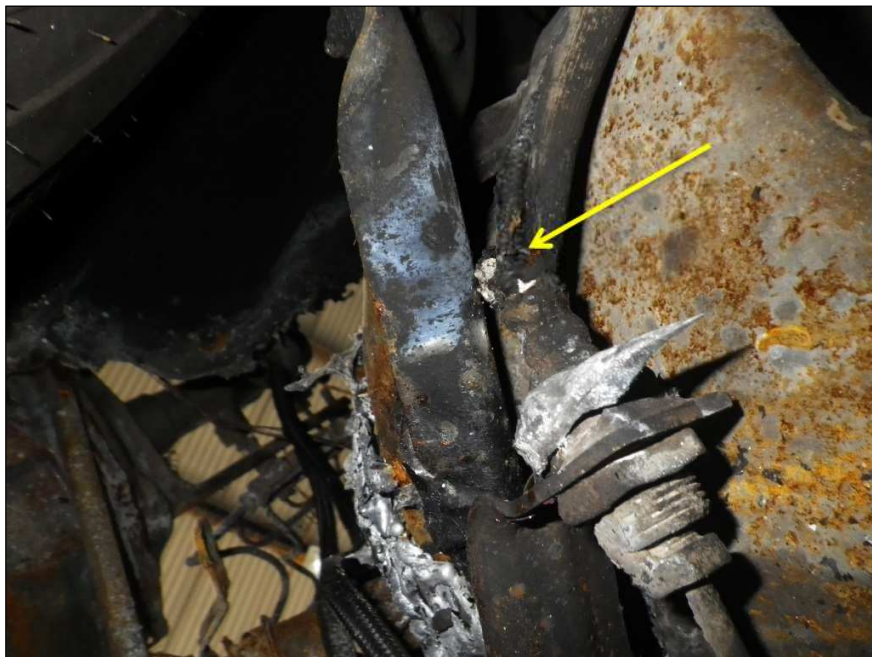
Photograph 4

View of damage (split or crack) in driver side brake line.

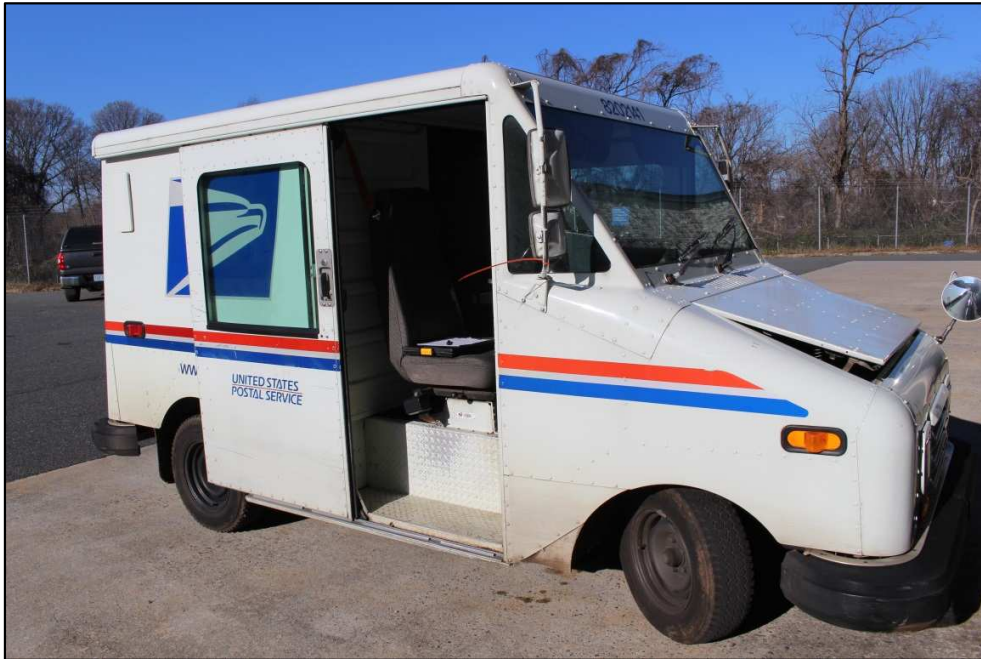
Photograph 1
Right side of vehicle.

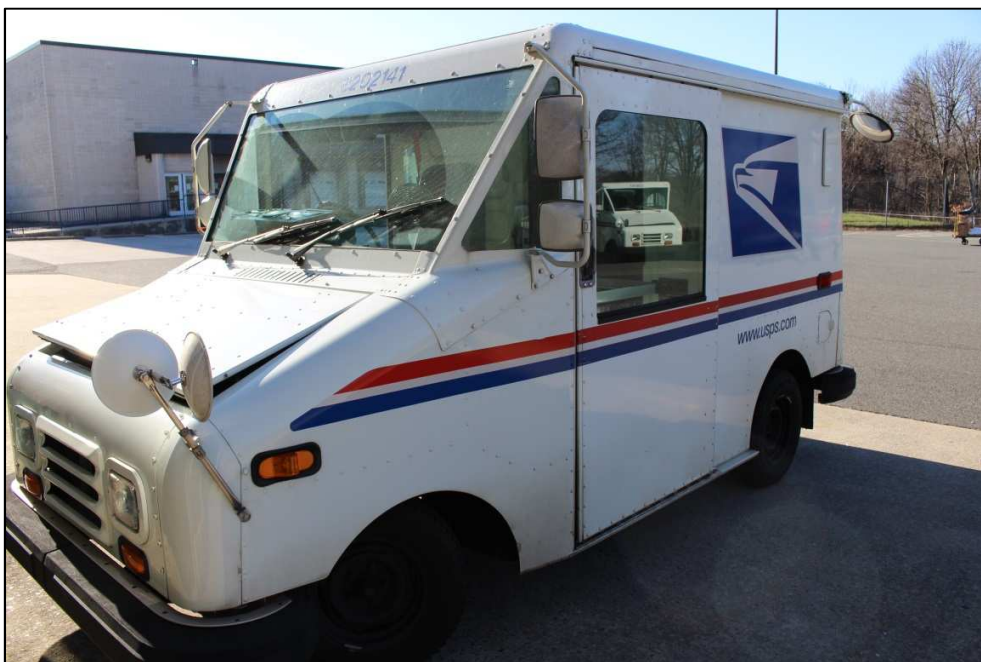
Photograph 2
Left side of the vehicle.

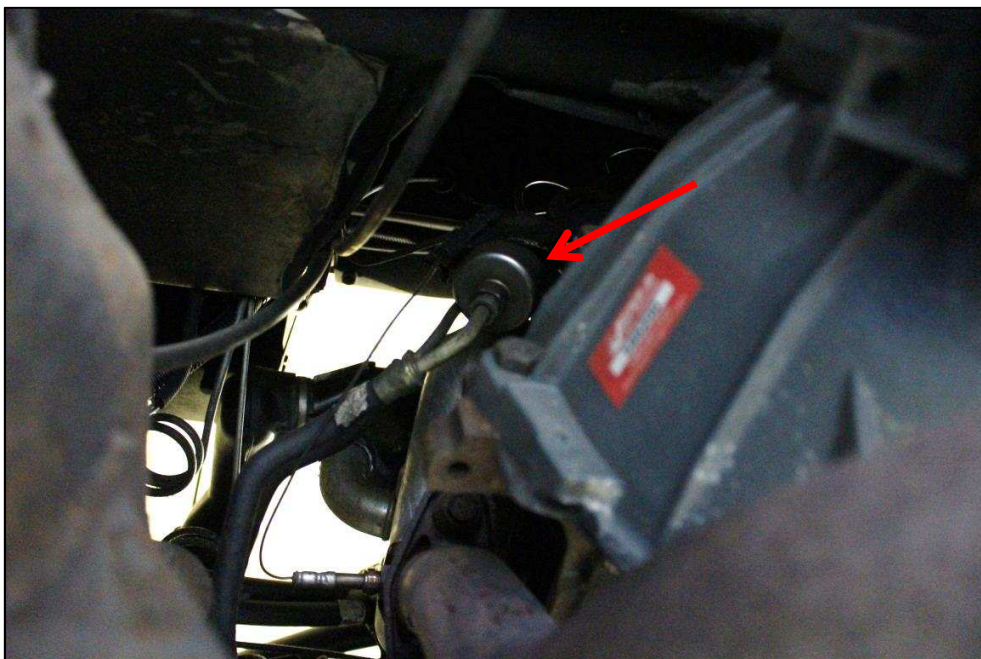
Photograph 4
Undercarriage view of fuel filter located on the left side of the engine.

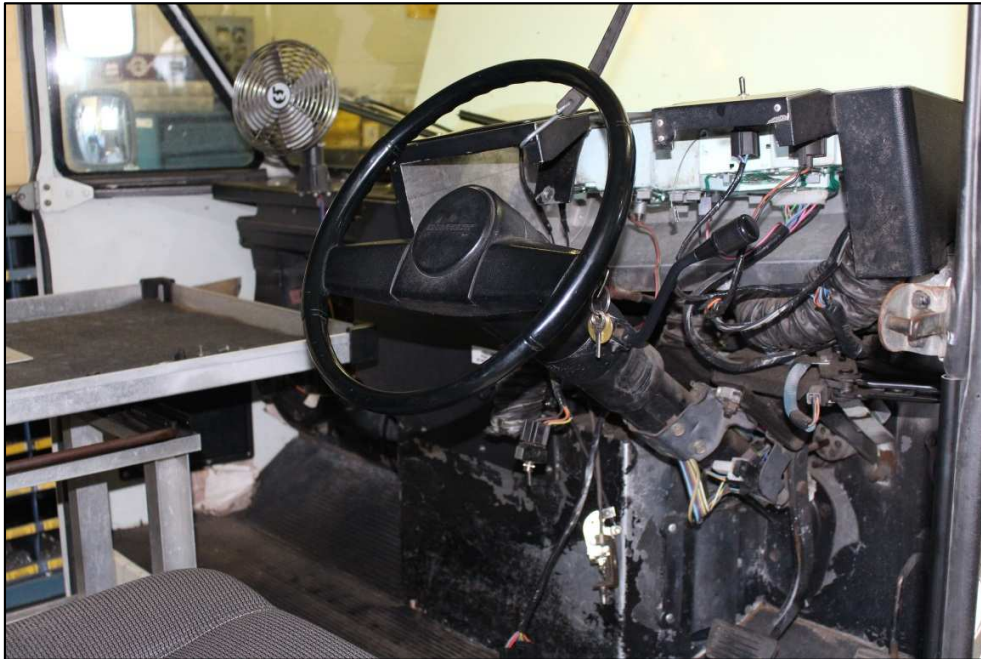
Photograph 5

Overview of instrument panel area – the panel is in the open position.

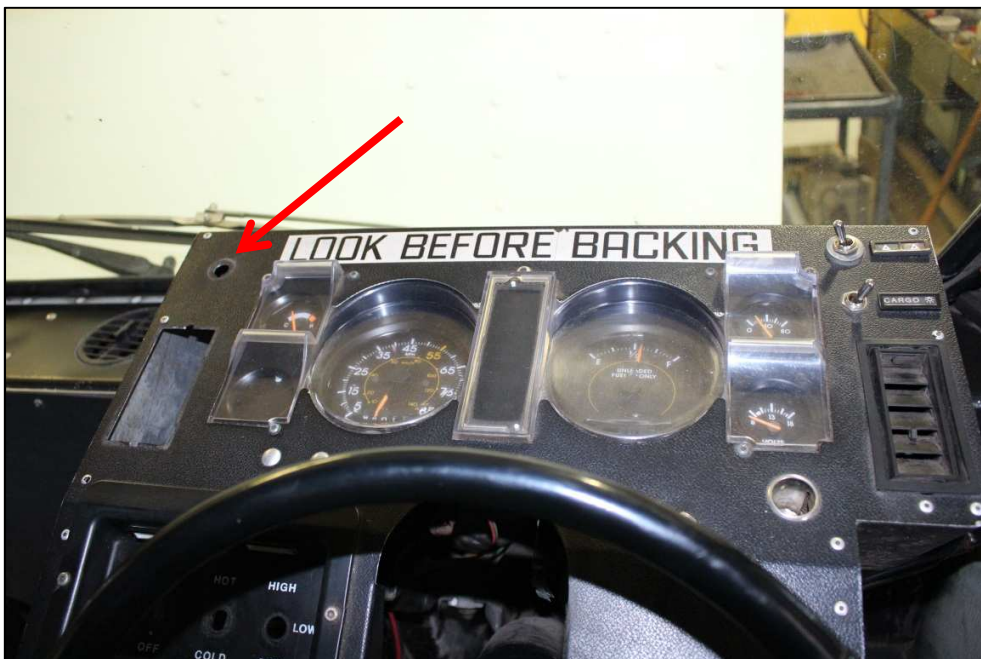
Photograph 6

Exterior view of instrument panel – fire originated left side of panel.

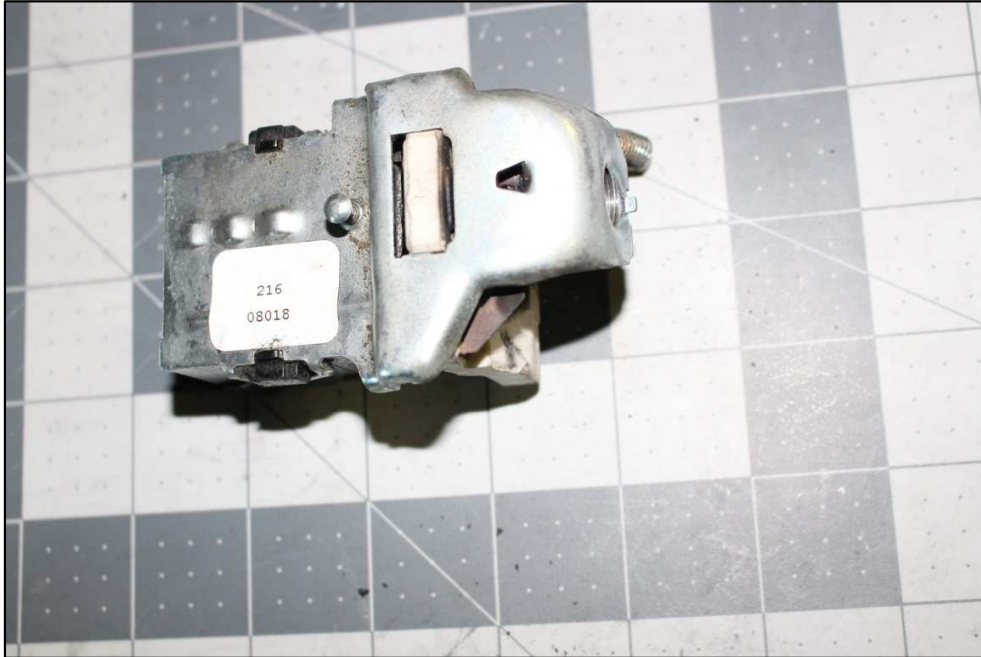
Photograph 9

Top view of headlight switch.

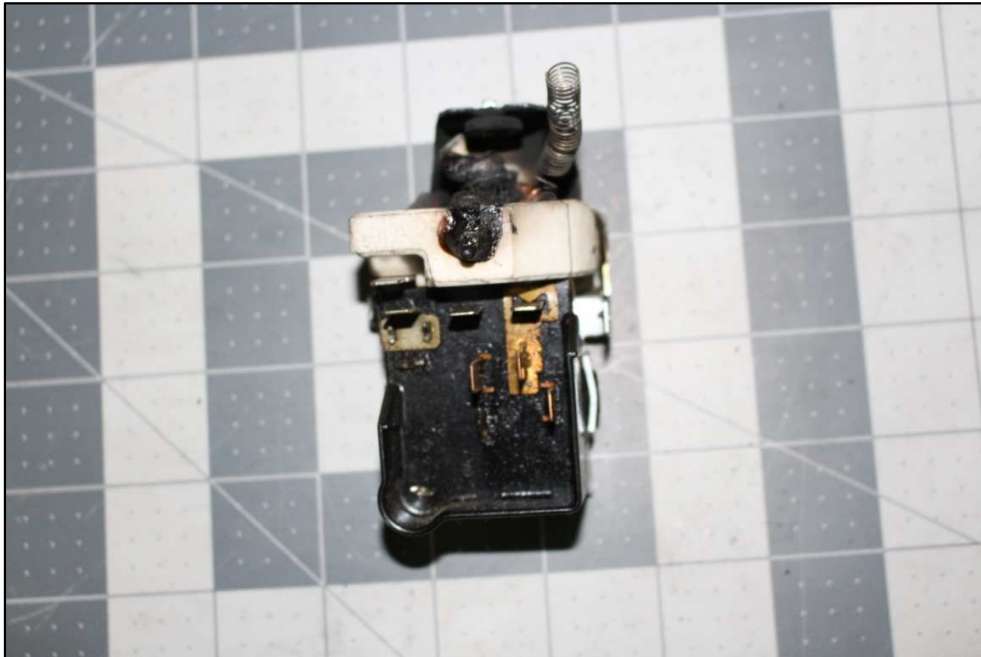
Photograph 11
Bottom section of headlight switch.

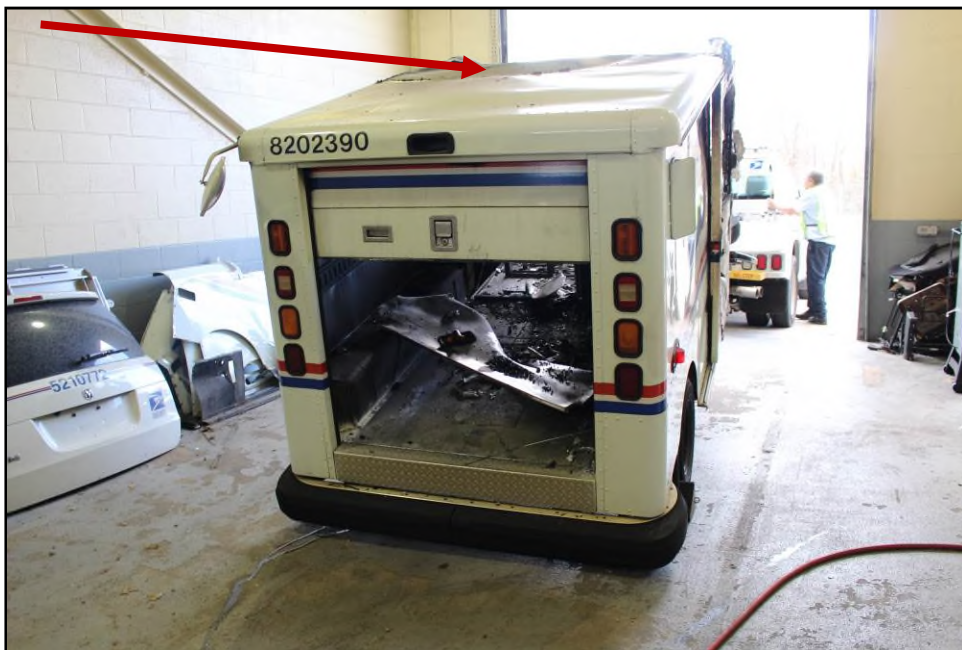
Photograph 2

No damage was observed to the exterior cargo area of the vehicle with the exception of blistered paint on the roof corresponding with fire spread from the direction of the engine and operator compartments. Based on the fire patterns observed, it was determined the fire initiated within the engine compartment right side near the rear of the engine then progressed into the operator's compartment through the windshield and bulkhead.

Rear view of the LLV, roof is melted and buckled.

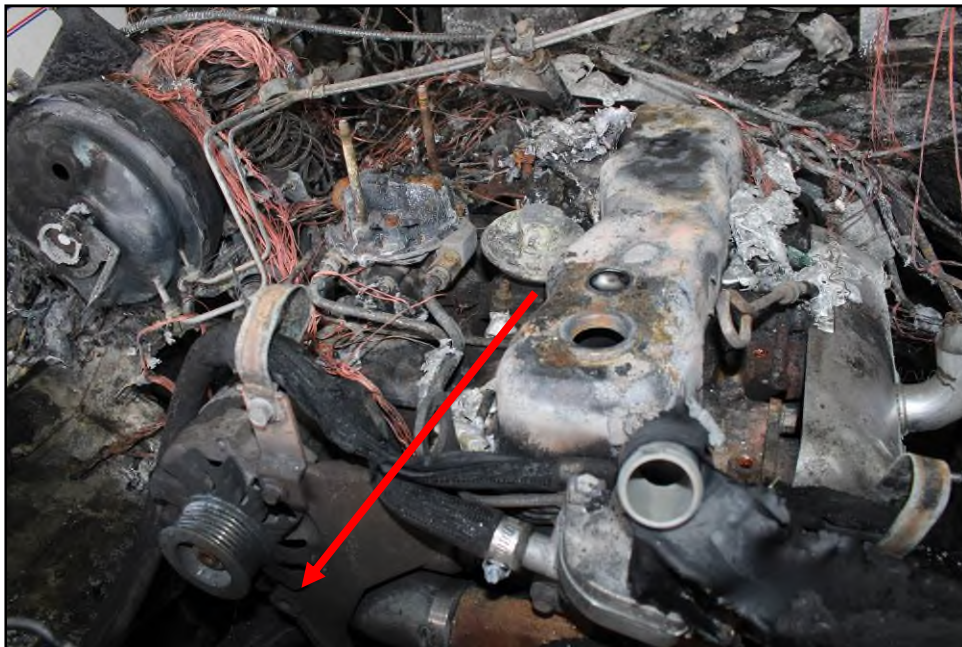
Photograph 4

Missing bolt on the alternator.

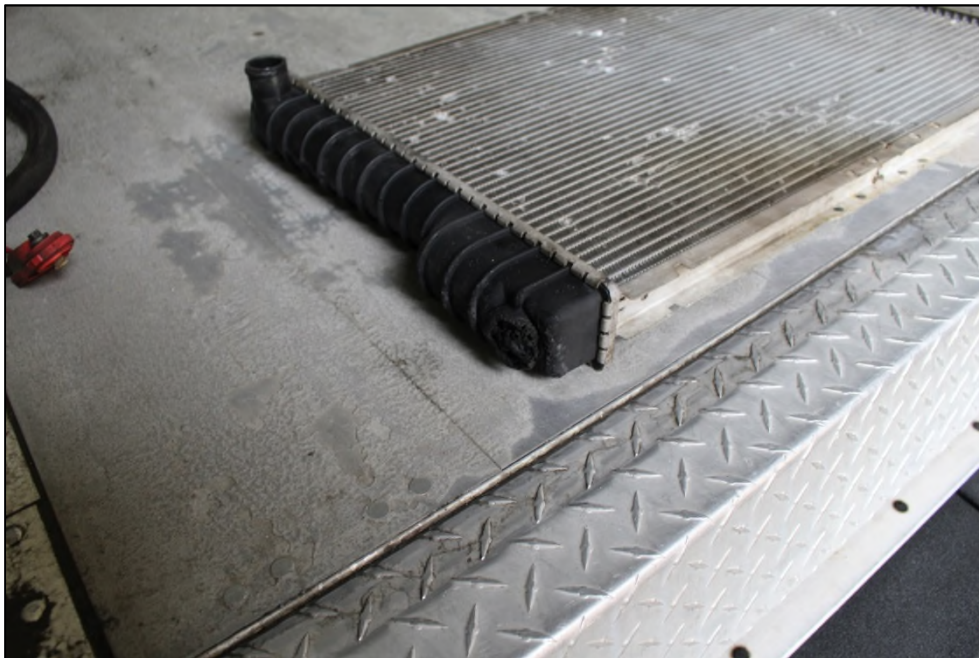
Photograph 8

View of the minor fire damage to the radiator that was removed.

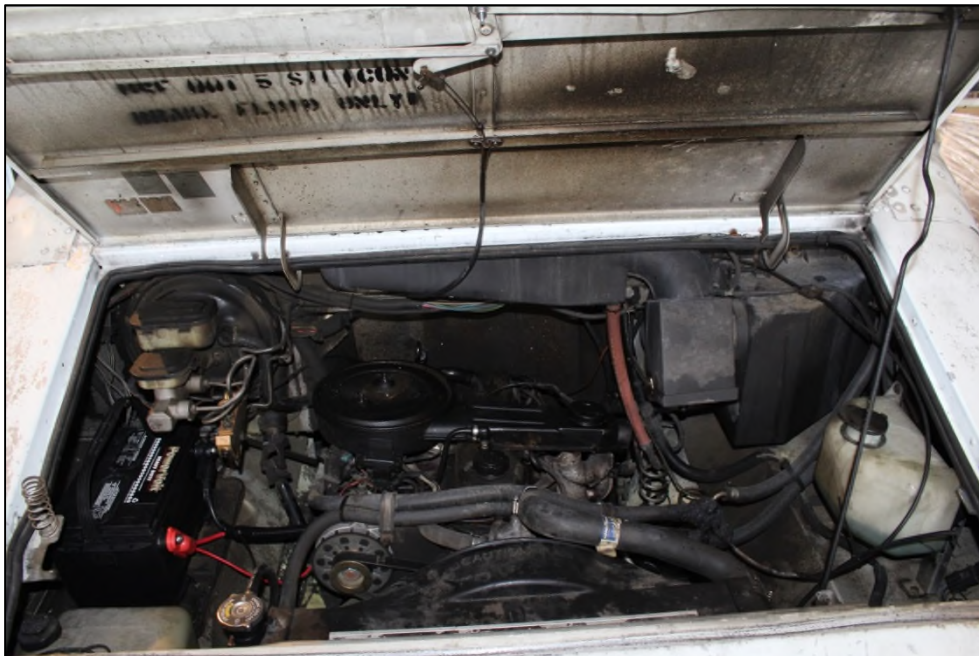
Photograph 10

View of the engine compartment, note the soot collected on the left side of the hood.
